# Roof Coating Guide

## Recoating Previously Painted Roof Surfaces

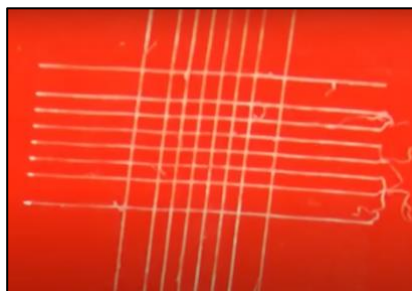
**1.**  
Hold the sharp cutting tool in a plane normal to the surface. With uniform pressure on the cutting tool and using a spacing of 2mm, make 8 parallel cuts not less than 25mm long. All of the cuts shall penetrate to the substrate. Make 8 more parallel cuts at right angles to and crossing the original cuts so that a lattice is formed.

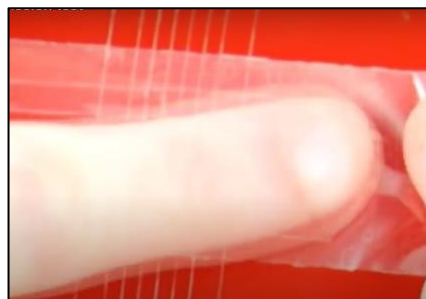
**2.**  
Apply tape (600 grade Scotch or equivalent) 20 mm wide over area of cuts by pressing down firmly against the coating to eliminate voids and air pockets.

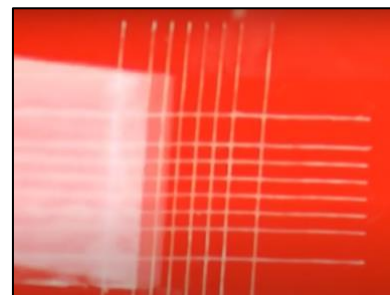
**3.**  
Sharply pull tape off at a right angle to the plane of the surface being tested.

Carefully examine the coating and the adhesive tape for detachment.

When the coated test section is tested in the manner described above there shall be no detachment of the coating from the substrate other than debris from the cutting operation.
